Fabrication Concerns in High-Mast Luminaire and Sign Supports

This brief summarizes Project 0092-00-16, "Structural Analysis of Sign Bridge Structures and Luminaire Supports," produced through the Wisconsin Highway Research Program for the Wisconsin Department of Transportation Research, Development & Technology Transfer Program, 4802 Sheboygan Ave., Madison, WI 53707.

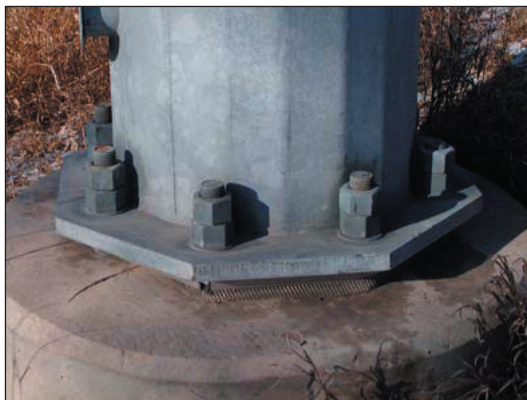
This high-mast luminaire support in Menomonee Falls, left, contains the recommended eight-bolt anchor structure and 1.5-inch-thick baseplate, and is in excellent condition after over 10 years of service (Fig. 3.71a, page 166 of final report). At right, the anchor rod stand-off in this sign support structure in Waukesha County increases the bending stresses in the anchor rods, resulting in fatigue sensitivity (Fig. 3.16, page 79).

- Anchor rod stand-off height has little impact on vibration frequency. Baseplate thickness is a more important factor; baseplates should be at least 1.5 inches thick.
- Four-bolt anchor rod configurations proved more susceptible to stress concentrations in the mast wall, and these configurations led to greater bending stresses in the anchor rods. Researchers recommend that four-bolt anchor rod configurations not be used in high-mast luminaire support structures.
- If inspected during fabrication and immediately after erection, luminaire supports may not require subsequent inspections during their 50-year service life.
